SUBJECT: Phase I Inspection Report
Rainey Lake Dam
Missouri No. 20267

RAINEY LAKE DAM
JASPER COUNTY, MISSOURI
MISSOURI INVENTORY NO. 20267

PHASE I INSPECTION REPORT
NATIONAL DAM SAFETY PROGRAM

JULY, 1980

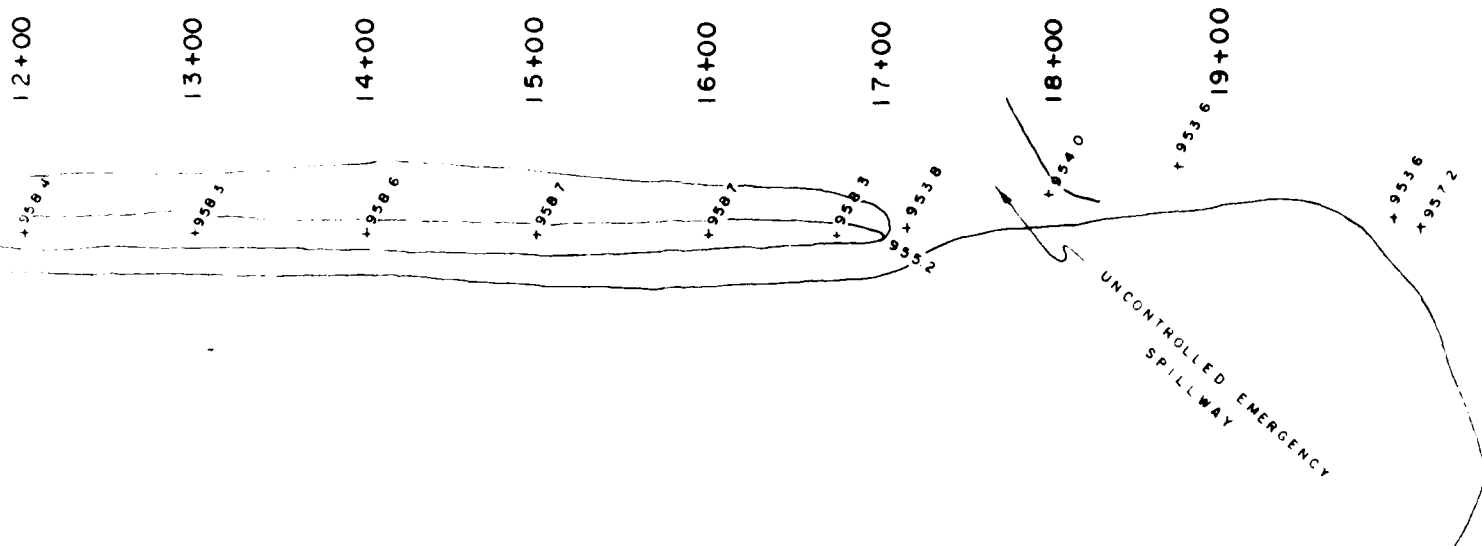
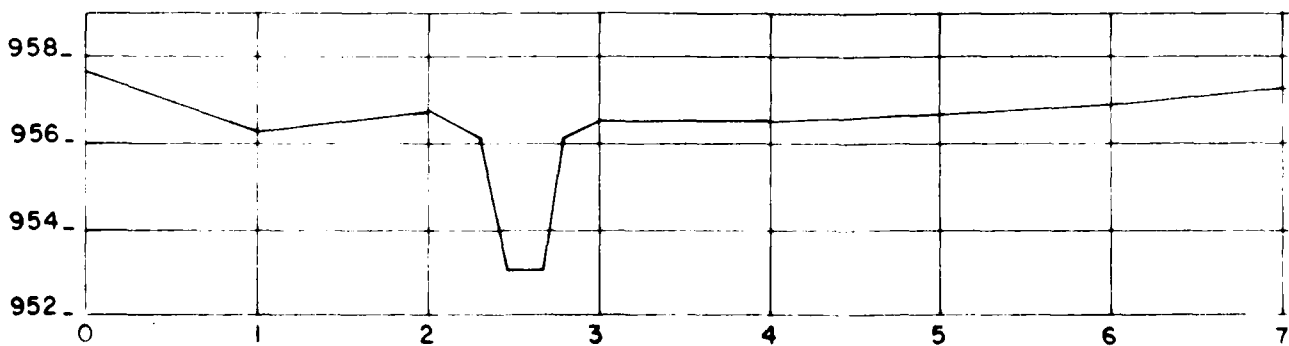
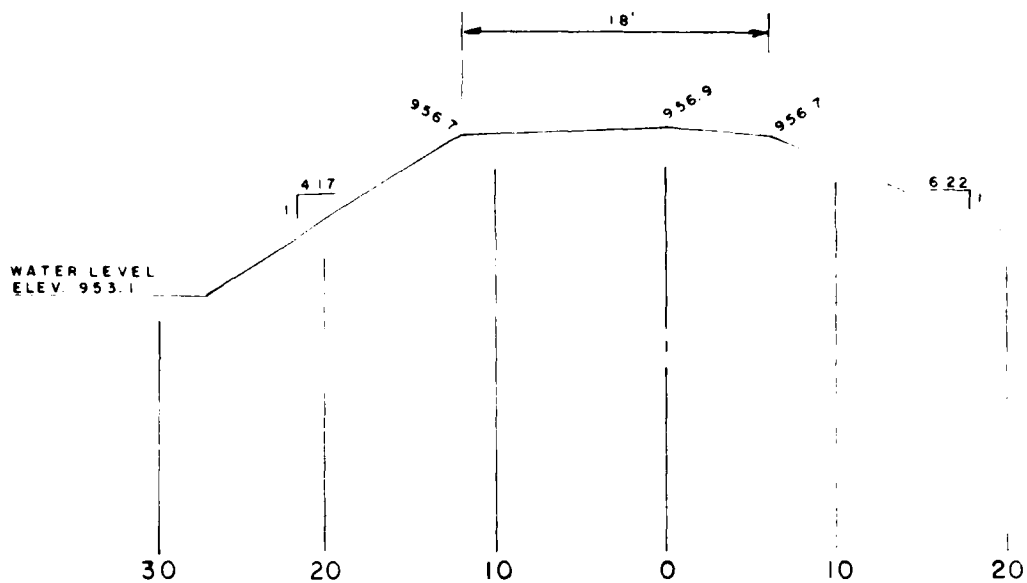
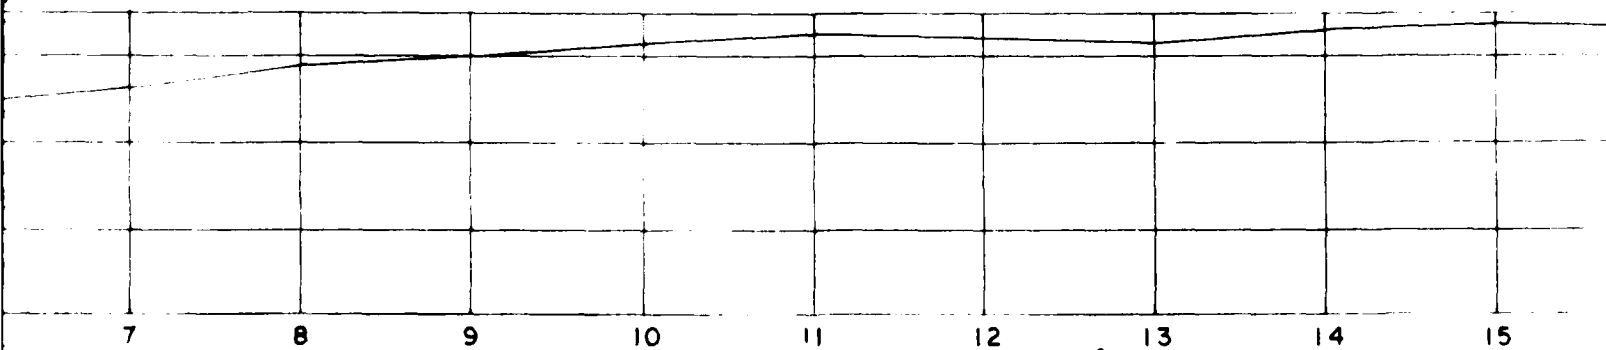
SHEET 3 APPENDIX A

Sheet 3 of Appendix A shows a plan, profile, and typical section of the embankments.
